Figure 1: Management Unit 3B (Shellness)

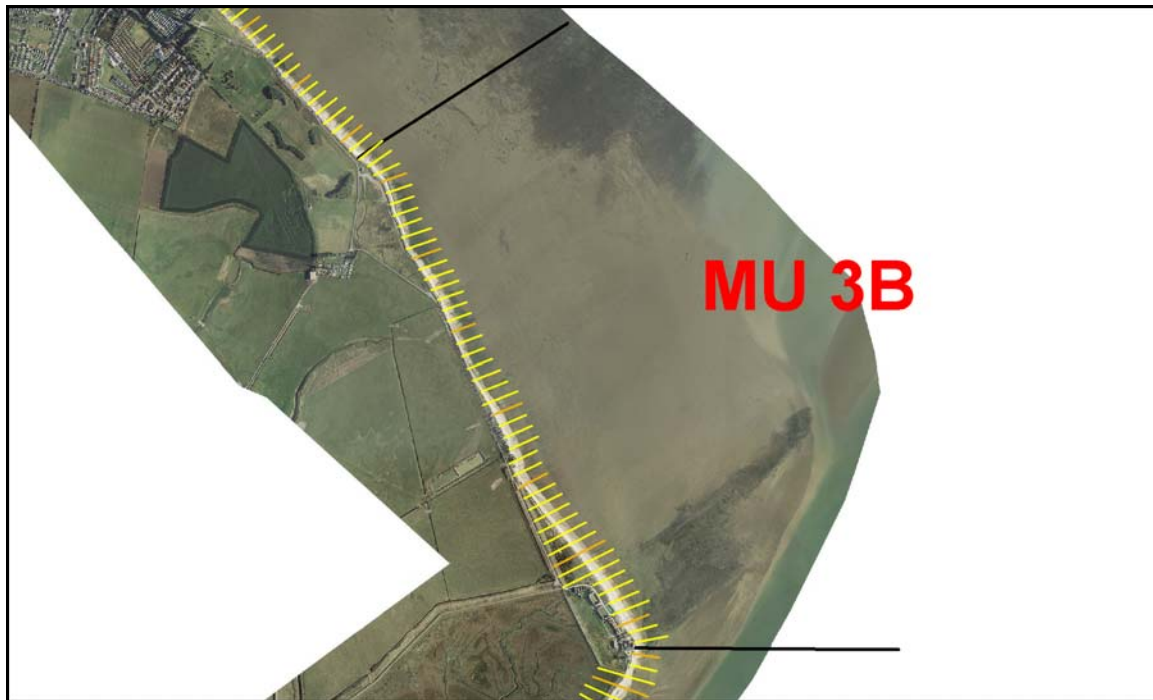
*Blue: Recycling Extraction Point*

*Red: Recycling Deposition Area*

The frontage comprises a managed sand (and shell) beach, which is backed by low-lying coastal grazing marsh. The northern section of this management unit is backed by the seawall which continues from MU3A; however this stops approximately 350m into the management unit. The central section has a groyned beach face for protection as several properties are located on the beach. The southern section of this management unit is also heavily groyned, with spacing approximately 50m apart. In areas with no property the groynes are more widely spaced and the beach generally lacks defences.
