**Figure 1: Management Unit 5C (Herne Bay)**

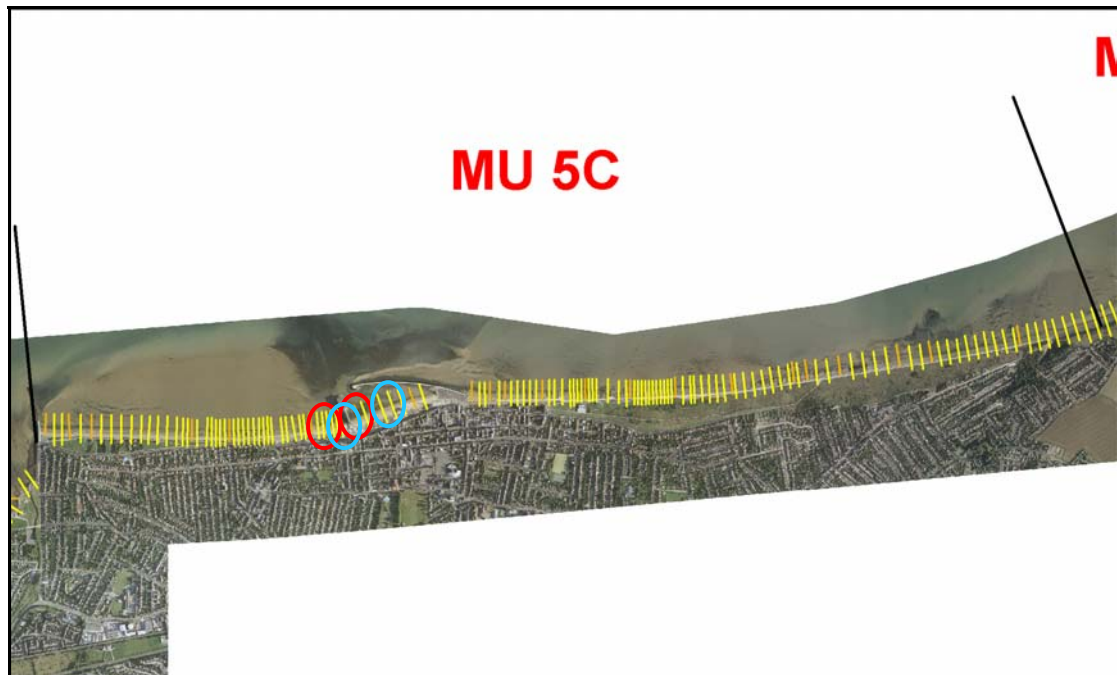
Blue: Recycling Extraction Point

Red: Recycling Deposition Area

Several shingle recharge schemes have been employed along this Management Unit, involving material being recycled from in front of the bandstand to a location adjacent to the east of the pier, from where it originated. Approximately 5,000m<sup>3</sup> is transported between these locations annually.
